NBS SPECIAL PUBLICATION **592**

# An Investigation of the Miyagi-ken-oki, Japan, Earthquake of June 12, 1978

Bruce R. Ellingwood, Editor

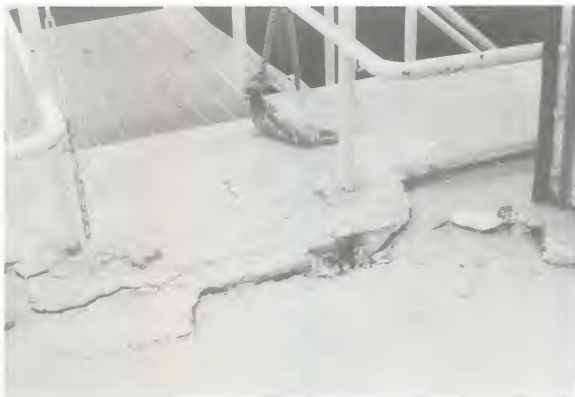
Figure 6.15 New Sendai Power Plant, Tohoku Electric Power Company: damage around the water intake structure from minor settlement. Other examples of minor settlement were observed throughout the site.

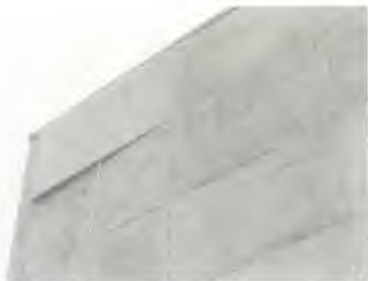
Figure 6.16 New Sendai Power Plant, Tohoku Electric Power Company: a loosened exterior facing panel in the turbine building. This was the only obvious damage to the exterior of the structure. The shear walls of the adjacent administration building showed extensive cracking.

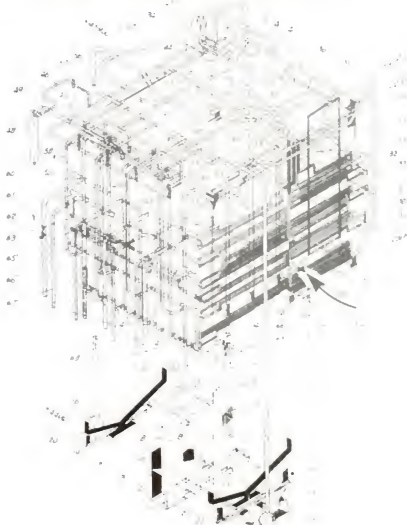
Figure 6.17 New Sendai Power Plant, Tohoku Electric Power Company. The arrow points to the location of the damaged horizontal spacer tubes in the 600-MW boiler of Unit No. 2. (See Figure 6.18).

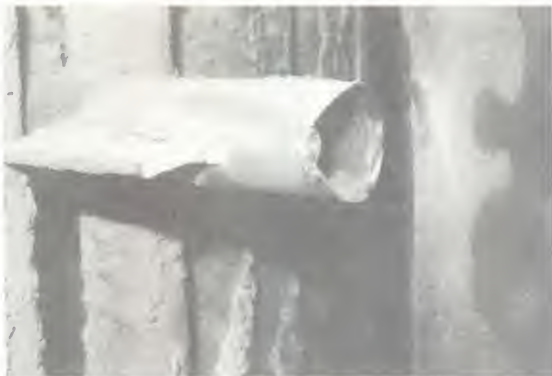
Figure 6.18 New Sendai Power Plant, Tohoku Electric Power Company: damage to the two boilers consisted of shearing of spacer tubes for the furnace platen cooler tubes inside the boiler. (Tohoku Electric Power Company photograph)

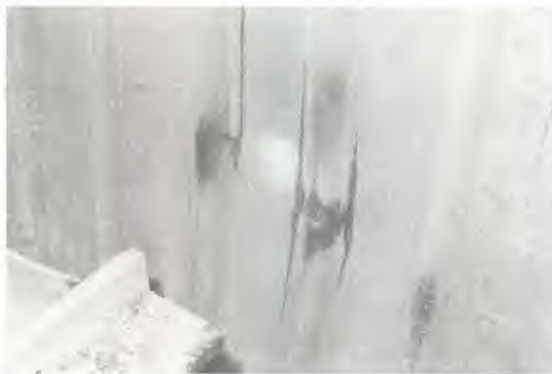
Figure 6.19 New Sendai Power Plant, Tohoku Electric Power Company: a view of the exterior of the boiler walls showing evidence that the suspended boiler had pounded against the surrounding support structure. (Tohoku Electric Power Company photograph)

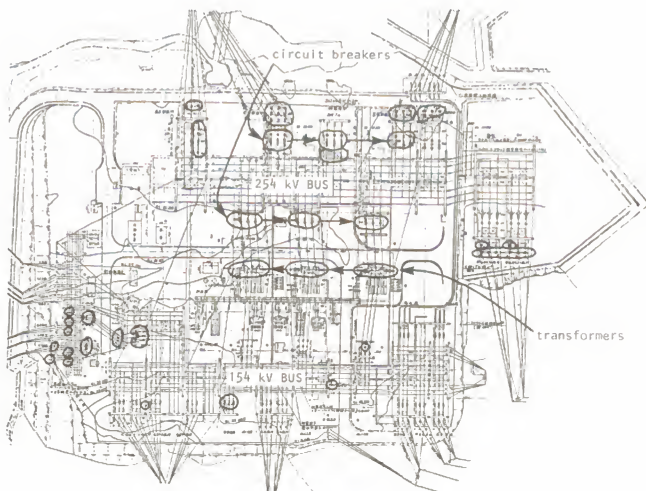
Figure 6.20 Sendai Substation, Izumi: plan of the facility showing the location of damaged equipment (circled). The solid contour lines indicate areas that were filled.

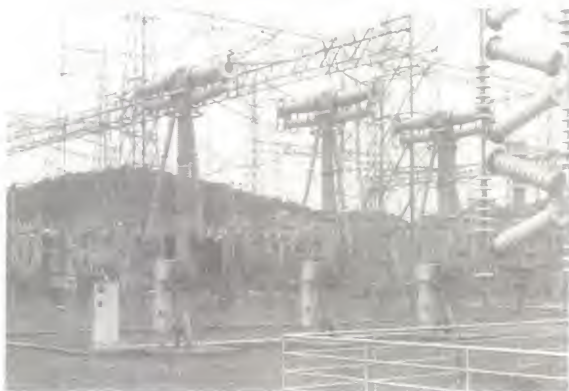
Figure 6.22 Sendai Substation, Izumi: three replaced 3-phase circuit breakers. This type of T-shaped circuit breaker suffered a high percentage of damage. Often the three symmetrical guides broke before the main stem. In all cases the structural steel supports appeared to be undamaged.

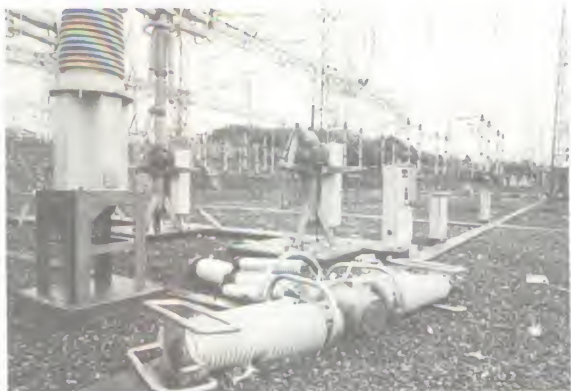
**Figure 6.23** Sendai Substation, Izumi: typical damage to 3-phase T-shaped circuit breakers (as shown in previous figure). Note the complete failure of one and the damage to the three guides of the second circuit breaker. All steel supports appear to be undamaged. The photograph was taken immediately after the earthquake before repairs were initiated. (Tohoku Electric Power Co. photograph)

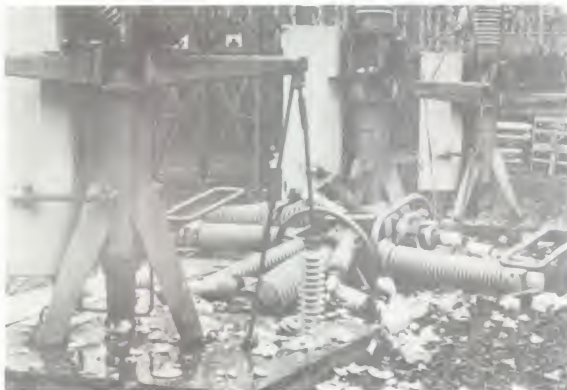
**Figure 6.24** Sendai Substation, Izumi: another three failed 3-phase, T-shaped circuit breakers. Note the failed main stems, the loose guide wires and the undamaged steel supports which are attached to their foundations. (Tohoku Electric Power Co. photograph)

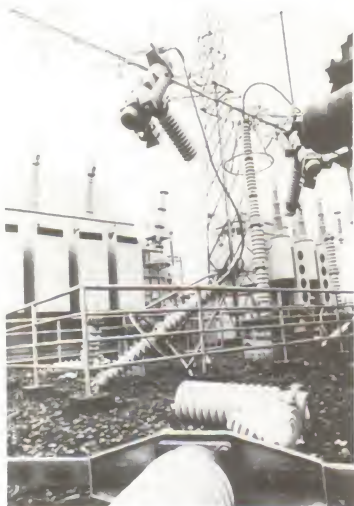
Figure 6.25 Sendai Substation, Izumi: damage to a circuit breaker (right), and two lightening arresters (center). The bushings of the transformer in the background appear to be undamaged; however, the lightning arrester is leaning. (Tohoku Electric Power Co. photograph)

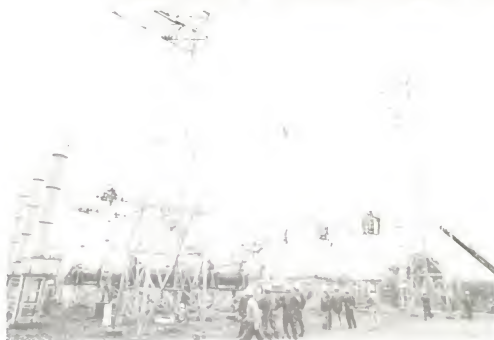
Figure 6.26 Sendai Substation, Izumi: Severe damage to circuit breakers (center of photograph - note the failed columns of live tank design, probably with gas reservoirs), current transformers (with the tapered bushings - some of the stems are also damaged), and reactors (to the left) with presumably broken connections. (Tohoku Electric Power Co. photograph)

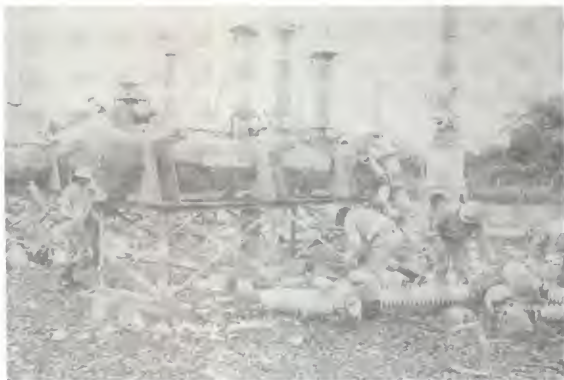
Figure 6.27 Sendai Substation, Izumi. Severe damage to several circuit breakers of live tank design. Note the lack of damage to the structural steel supports and the steel components of the equipment. (Tohoku Electric Power Co. photograph)

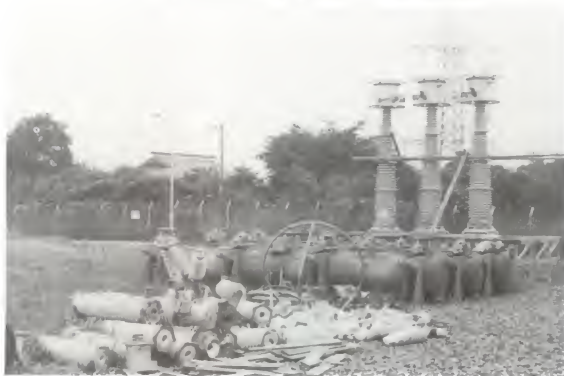
Figure 6.28 Sendai Substation, Izumi; one of several piles of broken equipment, including several line traps or reactors in the back (note the damaged base of the left stem) and the horizontal tanks of several circuit breakers of the live tank type (in the foreground are the failed columns of the circuit breakers and of other equipment).

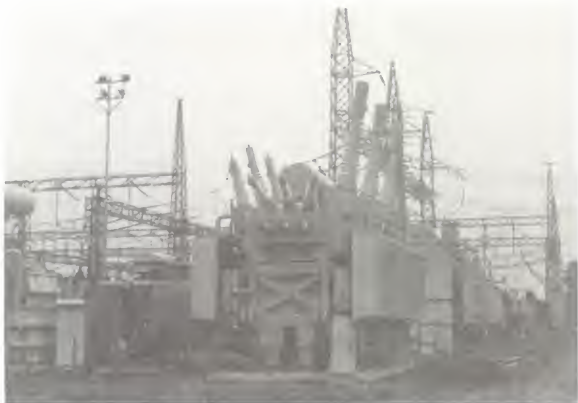
Figure 6.29 Sendai Substation, Izumi; a repaired but still disconnected transformer. All of the transformers at the substation lost some bushings or lightening arrestors. Some damaged parts were being replaced at the time of the investigation.

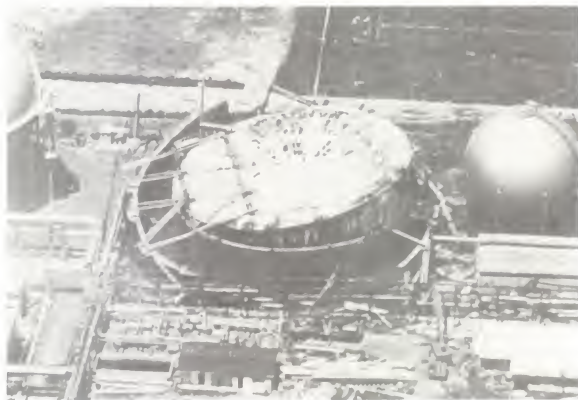
Figure 6.30 Haranomachi Plant, Sendai City Gas Bureau: an overall view of a collapsed propane gas holder and some of the surrounding propane storage tanks and affected pipeway and equipment. (Kahoku Newspaper Co. photograph)

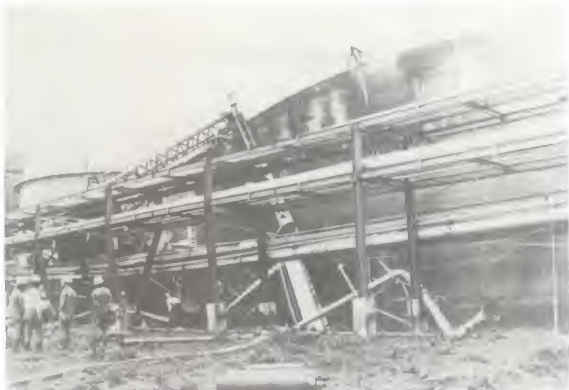
Figure 6.31 Haranomachi Plant, Sendai Gas Bureau; collapsed gas holder and the damaged adjacent pipeway structure just after the earthquake, (Sendai Gas Bureau Photograph)

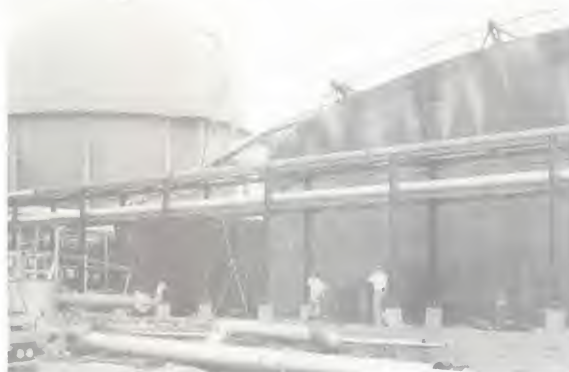
Figure 6.32 Haranomachi Plant, Sendai City Gas Bureau: The newly erected pipeway, with the collapsed holder in the background. Note the undamaged pressurized propene gas sphere in the back.

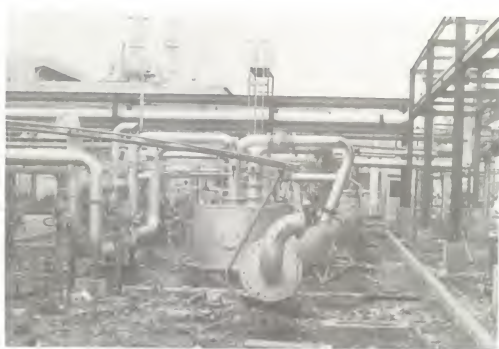
There was evidence of damage throughout the facility (Figures 6.33 through 6.38); however, none of the other tanks at the facility are believed to have suffered major damage. Some damage was due to pounding between buildings and pipes that penetrated the building walls (Figure 6.39). Unanchored pipe supports often moved on their pedestals, and reinforced concrete block structures suffered damage to their structural elements.

Figure 6.33 Haranomachi Plant, Sendai City Gas Bureau: damage to piping and other equipment and supports caused by impact from the collapsed gas holder and the adjacent pipeway. The newly erected pipeway is to the right.

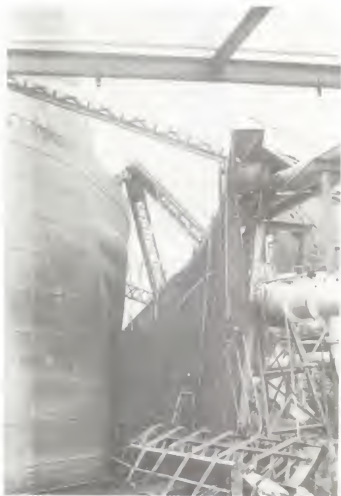
Figure 6.34 Haranomachi Plant, Sendai City Gas Bureau: damage to the telescoping gas holder and to some of the nearby pipeways and equipment. The trusses are portions of the original support structure that had surrounded the tank.

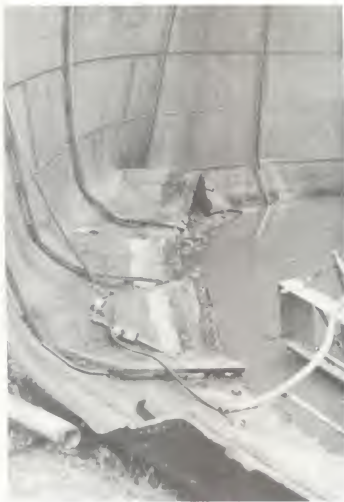
Figure 6.35 Haranomachi Plant, Sendai City Gas Bureau: buckling damage to the lower portion of one segment of the gas holder.

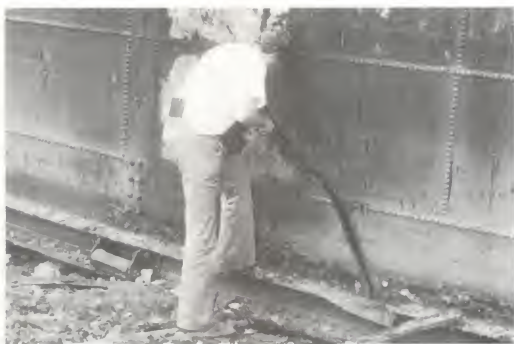
Figure 6.36 Haranomachi Plant, Sendai City Gas Bureau: a fracture of the 3/8-in. plate wall of the collapsed gas holder. The length of the fracture is approximately 1.5 m (5 ft).

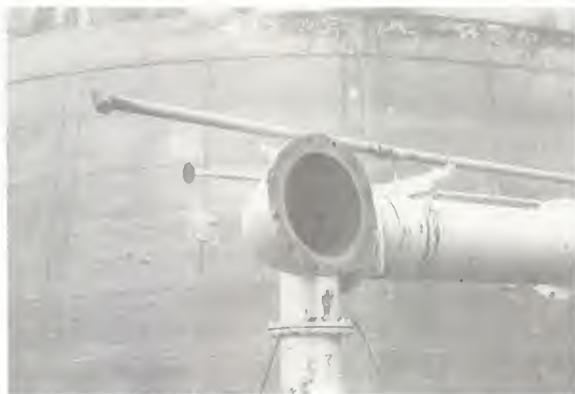
Figure 6.37 Haranomachi Plant, Sendai City Gas Bureau: sheared pipe flange connections in the pipeway structure in the vicinity of the collapsed gas holder.

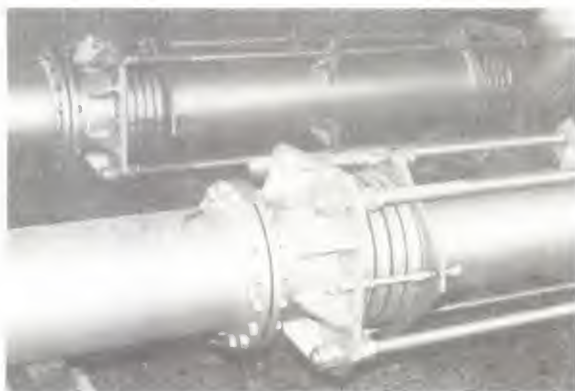
Figure 6.38 Haranomachi Plant, Sendai City Gas Bureau: undamaged expansion bellows that moved several inches during the earthquake.

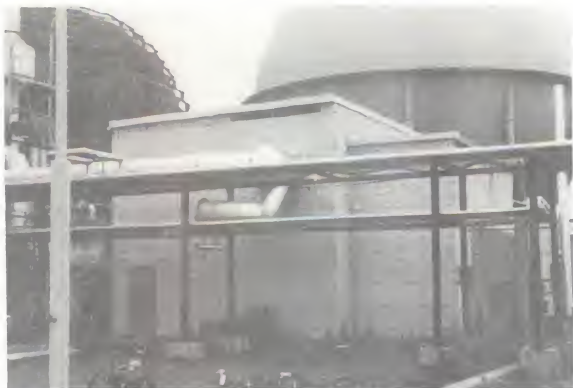
Figure 6.39 Haranomachi Plant, Sendai City Gas Bureau: a damaged reinforced concrete block structure. Some of the damage was due to pounding between the large diameter pipe and the structure at the pipe penetration.

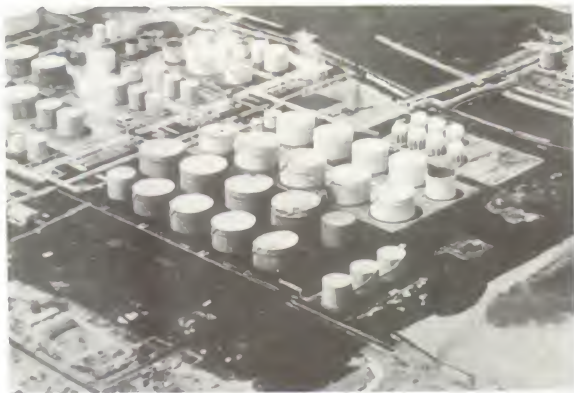
Figure 6.41 Sendai Refinery, Tohoku Oil Company, Ltd.: an overall view of the refinery's tank farm. The spilled oil appears as the dark area of the photograph. (Tohoku Oil Company photograph)

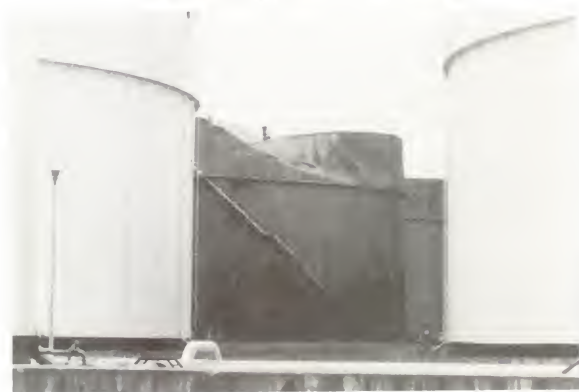
Figure 6.42 Sendai Refinery, Tohoku Oil Company, Ltd.: one of the three failed storage tanks. The damage illustrated is due to suction caused by rapid evacuation of the oil through the ruptured connection of the base and wall of the tank. The several tanks, of similar size, in the foreground are thought to be undamaged.

At the time of the investigation a thick film of oil still covered much of the refinery grounds. Thus, the fire hazard was great, and the investigating team was unable to observe the details of the damage to the tanks. It is believed that the tanks shown in Figures 6.42 through 6.44 failed at their bases. The oil drained rapidly, causing a vacuum inside, which imploded the tanks. Three other tanks suffered damage and will need repair.

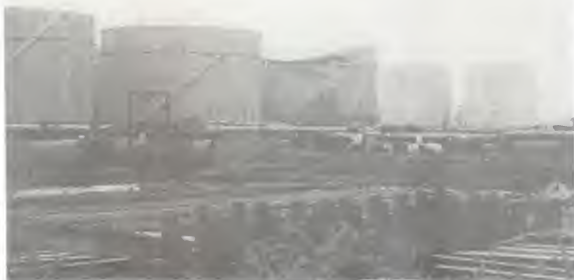
Figure 6.43 Sendai Refinery, Tohoku Oil Company, Ltd. Two other failed TC oil storage tanks.

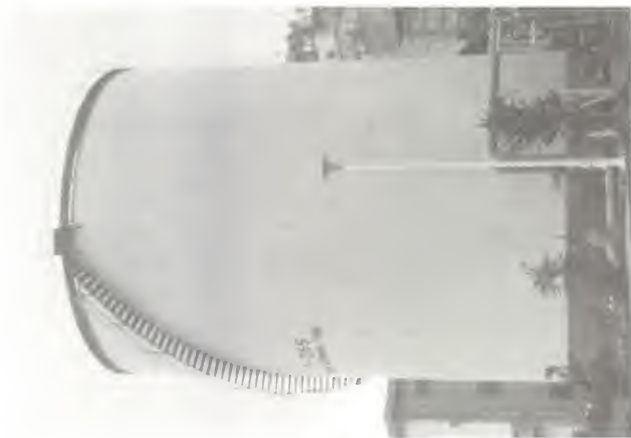
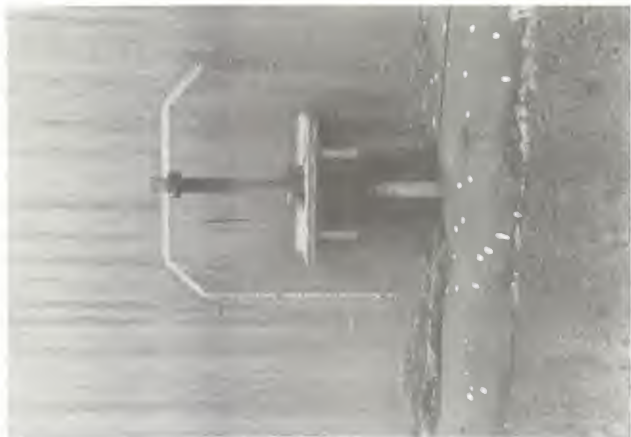
Figure 6.45 Sendai Refinery, Tohoku Oil Company, Ltd. A large water storage tank (left) near the main refinery complex appeared to have experienced significant rocking. Detail (right) of one of the pulled-out, or stretched, anchor bolts of the water storage tanks shown at left.

Another large water storage tank experienced interesting damage (Figure 6.45). The welded steel plate tank was anchored with bolts, spaced at approximately 6 ft (2 m), and embedded in a continuous concrete pad. The bolts around the entire circumference were stretched, or more likely, pulled out from their embedment from 1 to 6 in (2.5 to 15 cm). However, there was no apparent buckling or other damage to the steel base of the tank.

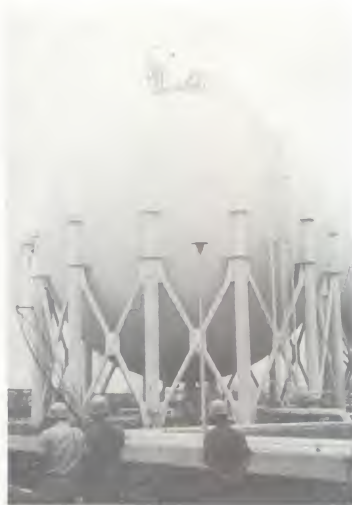
Figure 6.46 Sendai Refinery, Tohoku Oil Company, Ltd.: an undamaged LPG storage tank. Note the heavy diagonal bracing in the supporting structure.

Visual inspection of several of the LPG tanks at the refinery, revealed no damage. There were minor cracks in the concrete supports and some spalling of paint in the steel connections due to working. The tanks were designed for 0.30g peak ground acceleration. As illustrated in Figure 6.46, the tanks were heavily braced with diagonal braces with circular cross-sections.

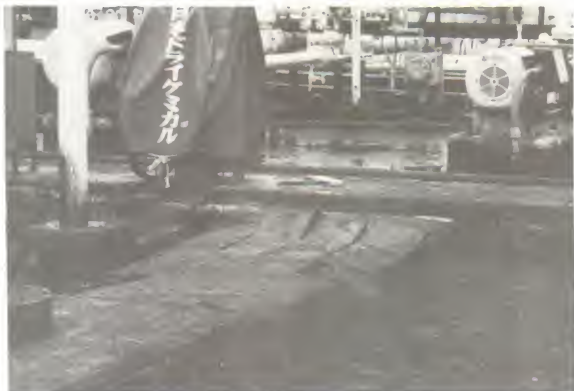
Figure 6.48 Sendai Refinery, Tohoku Oil Company, Ltd.: ground settlement at the refinery.

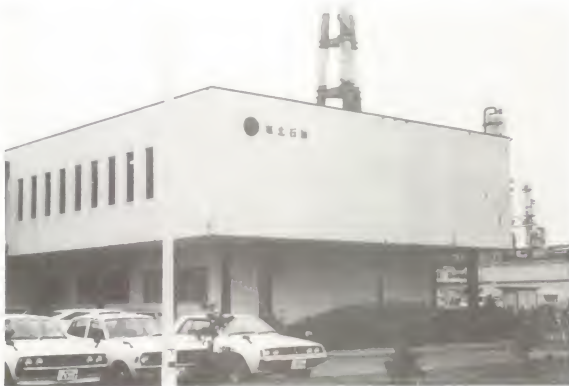
Figure 6.49 Sendai Refinery, Tohoku Oil Company, Ltd.: A wing of the damaged steel-framed administration building. Damage was obvious only to the architectural finishes.

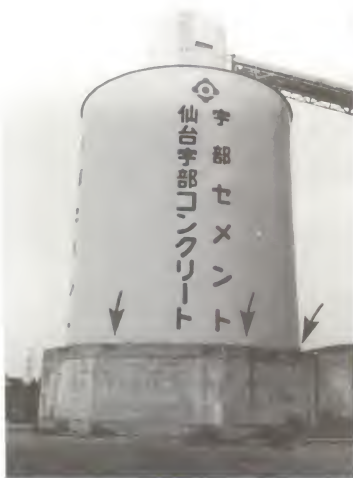
A large welded steel plate storage tank, containing sand and gravel, and reportedly full during the earthquake, which was supported on a massive concrete pedestal, suffered buckling along several locations at the base of the steel plate (Figures 6.52 and 6.53). It seems apparent that the buckling was caused by overturning forces, rather than by sloshing of the contents. The tank and its superstructure and support structure did not experience any other damage.

Figure 6.53 Concrete Batch Plant, Sendai: a detailed view of the damaged base of the sand and gravel storage tank. Note the closely spaced anchor bolts. Similar damage occurred at several locations along the circumference.

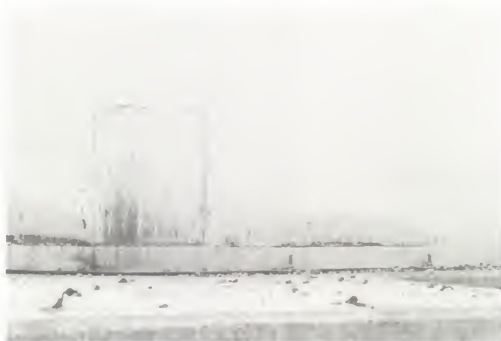
Figure 6.52 Concrete Batch Plant, Sendai: a large gravel-and-sand-storage tank experienced buckling of the welded steel plate at its base.

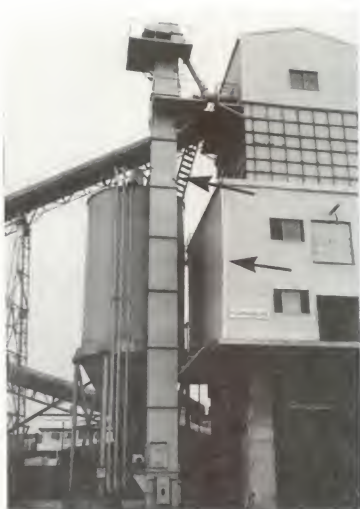
One of the light steel-framed structures at the plant was damaged, as shown in Figure 6.54, apparently because of inadequate lateral bracing. The differential displacement caused by the failure of the structure was responsible for damage to a connecting vertical steel stack and associated piping. The stiffer first floor reinforced concrete structure was undamaged. A similar structure, Figure 6.55, located in the immediate vicinity of the plant and properly braced with light steel cable or rod braces, did not suffer damage. The latter type of construction is quite common in Sendai, and generally appeared to experience no significant damage.

Figure 6.54 Concrete Batch Plant, Sendai: displacement due to damage to the light, unbraced steel superstructure damaged the vertical stack and the conveyor belt structure.

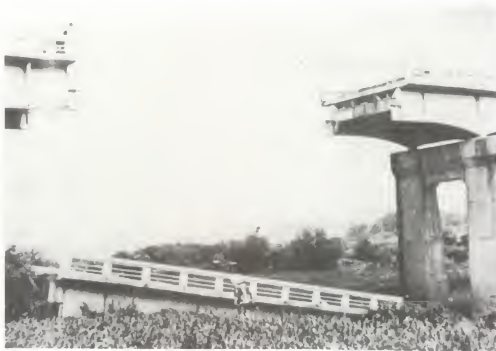
Figure 7.3 Kin-noh Bridge. View of the collapsed suspended plate girder span. Similar damage occurred to bridges in the 1971 San Fernando and 1976 Guatemala earthquakes because of lack of superstructure restraint and small bearing seats. Suspended spans are no longer used in seismically active areas. (Courtesy J.M.O.C.)

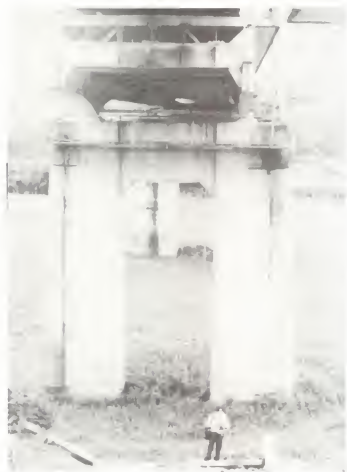
Figure 7.4 Kin-noh Bridge. The only visible pier damage occurred at Pier 8, which is adjacent to the collapsed suspended span. Shear cracking extended 125 cm through the 152 cm deep pier, approximately one-fourth the way up the column from grade.

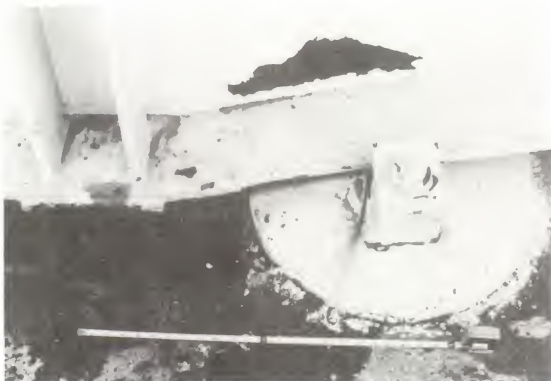
Figure 7.5 Kin-noh Bridge. The girders at Pier 8 displaced longitudinally toward the abutment 55 cm allowing the unrestrained suspended span to drop off the 45 cm hinge seat. The movable girder bearing plate came to rest at the edge of the pier cap. The fixed bearing on Pier 7, the opposite side of the suspended span, displaced longitudinally 0.5 cm.

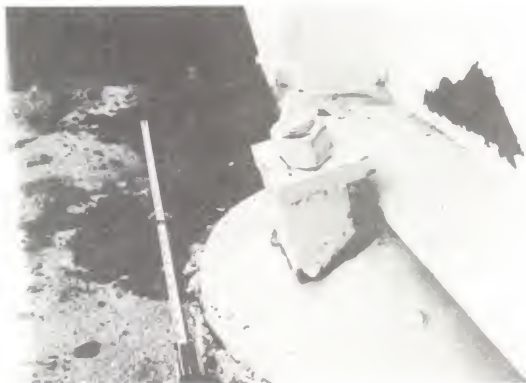
Figure 7.6 Kin-noh Bridge. Evidence of minor transverse displacement of the main girder with broken keeper. This reportedly occurred at the time of the February 20 earthquake.

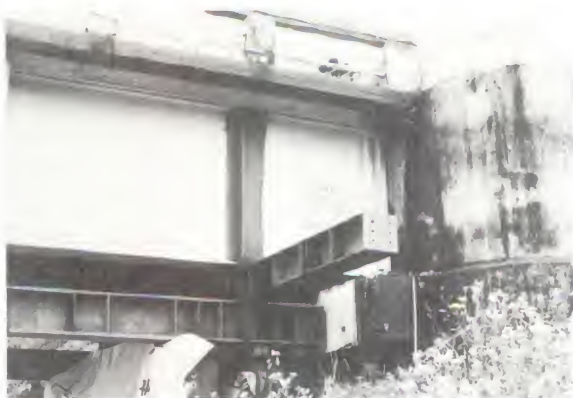
Figure 7.7 Kin-noh Bridge. Damaged abutment from the February 20, 1978, 6.7 magnitude earthquake. New web stiffener at point of temporary shoring.

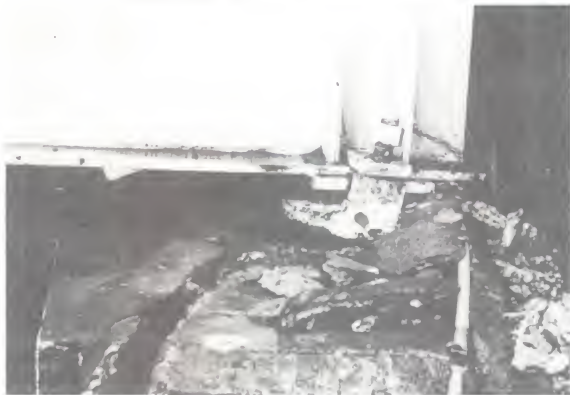
Figure 7.8 Kin-noh Bridge. Detail of bearing damage and abutment ledge failure, from February earthquake. Note extension of anchor bolt caused by 20 cm displacement of span towards abutment.

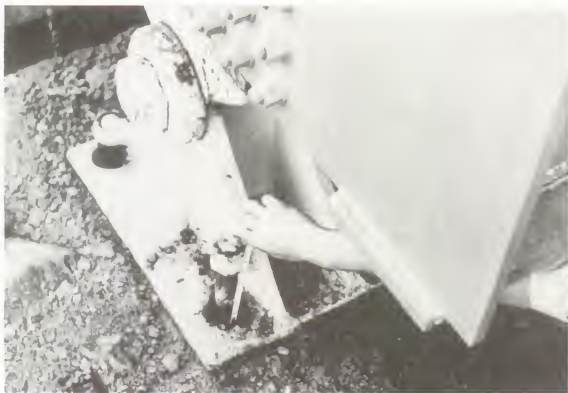
Figure 7.9 Kin-noh Bridge. Extension of anchor bolts at Pier 6. The foreground shows a portion of repaired lower chord truss member.

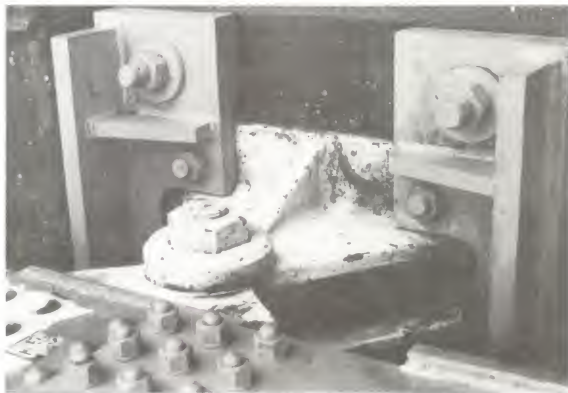
Figure 7.10 Kin-noh Bridge. Bearing restraining device used on the repaired bearing supports of the truss spans. The restrainers were placed before the June 12 event.

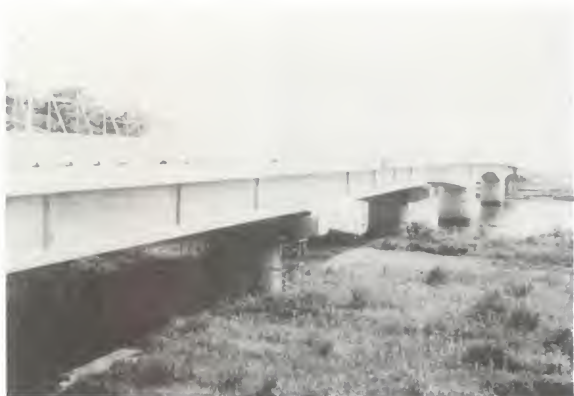
Figure 7.11 General view of the Yuriage Bridge showing the first two columns which were heavily damaged.

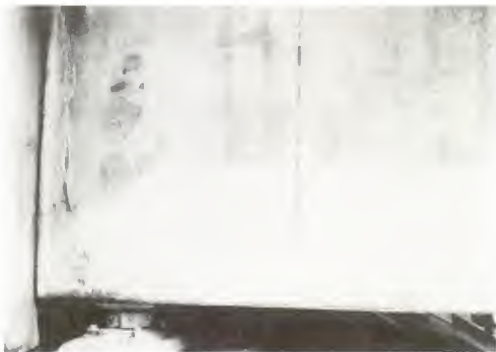
Figure 7.12 Yuriage Bridge. Liquefaction in the flood plan below the bridge.

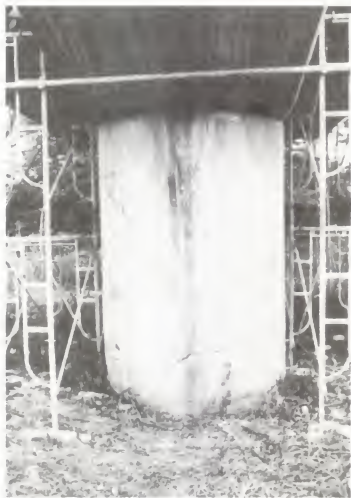
Figure 7.13 Yuriage Bridge. Evidence of light girder impacting with the abutment and pronounced shear cracking of exterior girder at the bearing.

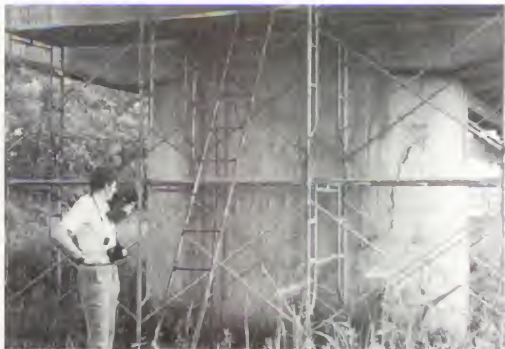
Figure 7.14 Yuriage Bridge. Pier 1, founded on a caisson 19 m deep and 2 m by 4 m in plan, suffered heavy shear cracking. The pier cap was reported to have settled uniformly 5 cm.

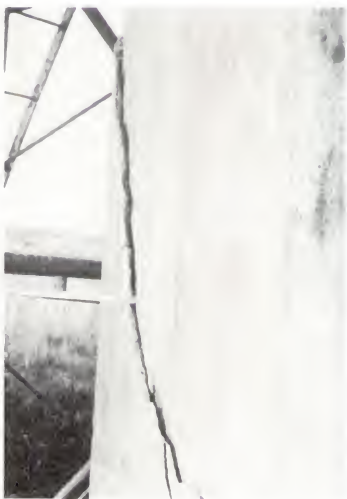
Figure 7.15 Yuriage Bridge. The face of Pier 1 showing severe distress. The plaster of paris patchwork is used to determine if additional pier cracking has occurred.

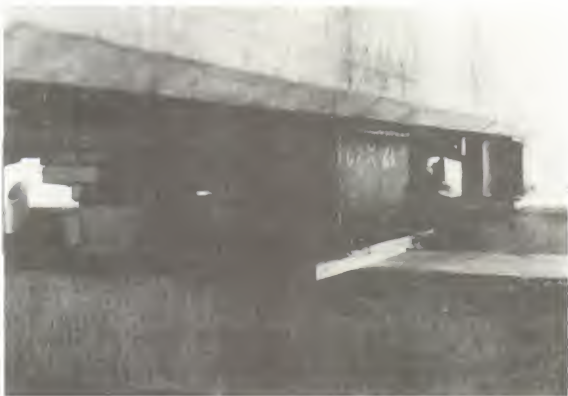
Figure 7.16 Yuriage Bridge. Detail showing 1 cm offset of cracking, indicating torsion in pier.

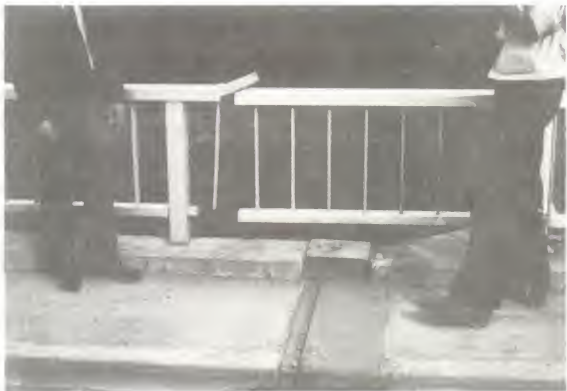
Figure 7.17 Yuriage Bridge. Temporary girder supports at Pier 1. Bearings showed evidence of girder displacement - broken keeper and containment plates.

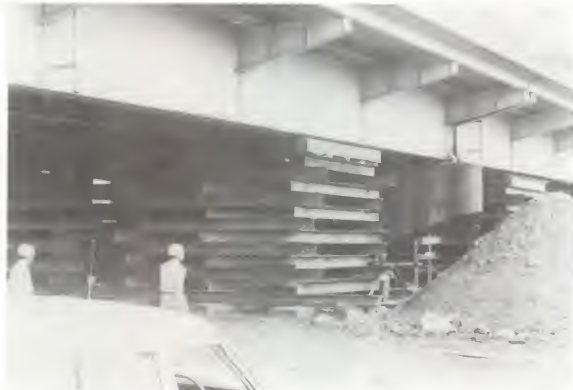
Figure 7.20 Sendai Ohashi Bridge. Temporary cribbing used to support the steel plate girders.

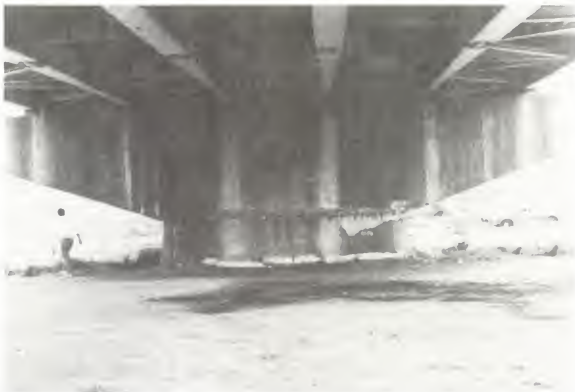
Figure 7.21 Sendai Ohashi Bridge. Typical pier configuration. The cross pier dimensions are approximately 5 m x 2 m. Note the massive pier caps. (Courtesy J.M.O.C.)

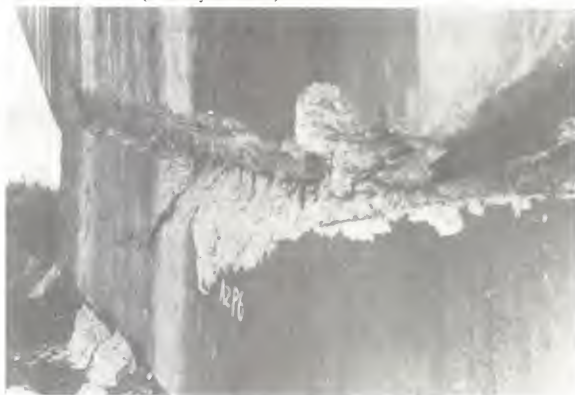
Figure 7.22 Sendai Ohashi Bridge. Typical pier damage at the construction joint between pier and cap. The vertical rebars are buckled across the joint. Significant concrete spalling is evident. Horizontal cracking around the pier was discovered upon excavation of soil around the piers. (Courtesy J.M.O.C.)

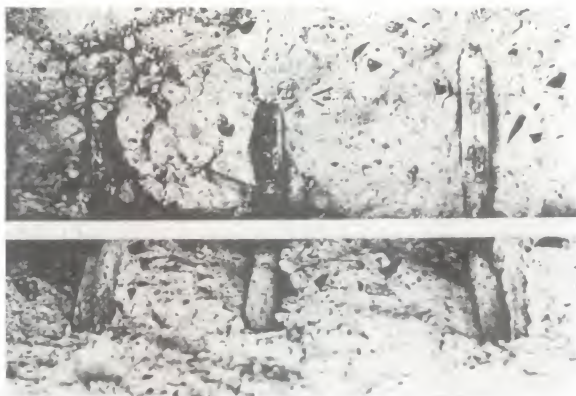
Figure 7.23 Sendai Ohashi Bridge. Detail showing buckled vertical rebar at the construction joint. Strong motion records in Sendai indicated approximately 100 gal. vertical accelerations. (Courtesy J.M.O.C.)

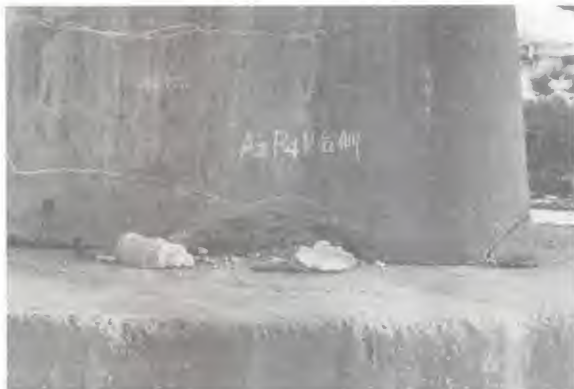
Figure 7.24 Sendai Ohashi Bridge. Typical damage to the base of a pier before repair.

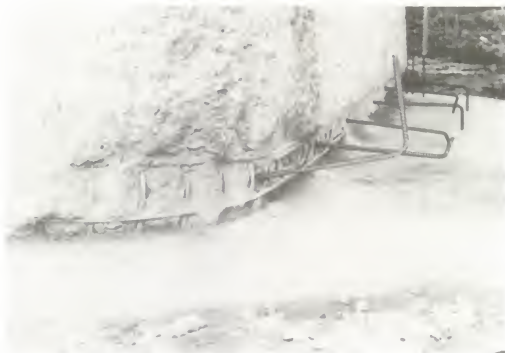
Figure 7.25 Sendai Ohashi Bridge. Typical damage being repaired at the base of the pier. Note the outward buckling of the underformed vertical rebar. The concrete cover had been roughened, the footing strengthened, and additional rebar placed to strengthen the pier.

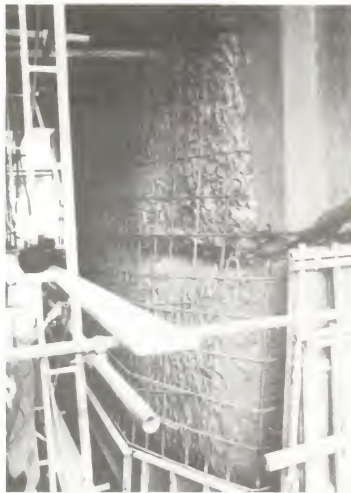
Figure 7.26 Sendai Ohashi Bridge. Details showing the added reinforcing concrete form work. The pier thickness will be increased on each side by 50 cm at the top, tapering to 70 cm at the base.

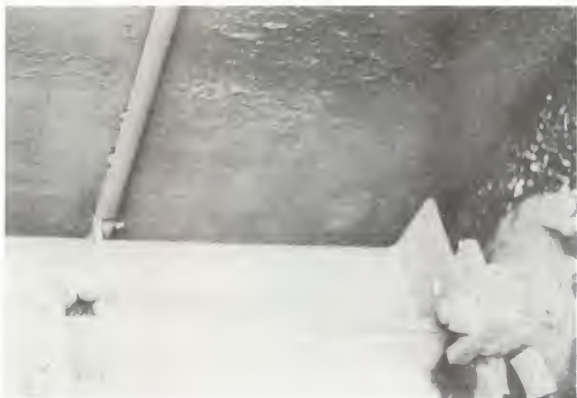
**Figure 7.27** Sendai Ohashi Bridge. Abutment damage. Bearing plate broken and evidence of girder impact at abutment.

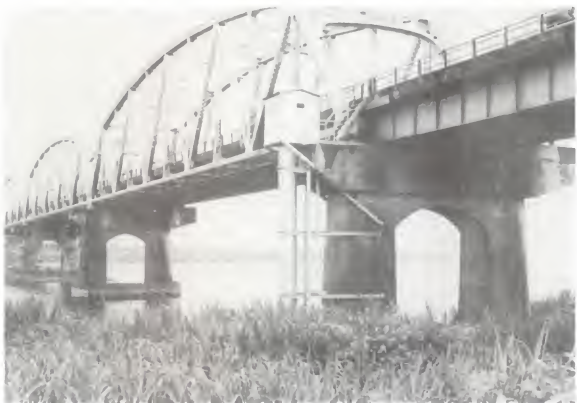
The Abukuma Bridge (Figure 7.28), located about 20 km south of Sendai on National Highway, Route 6, near the junction of Route 4, is a two-lane, 17-span structure 571 meters long. The structure is comprised of eight plate girder approach spans, each 18 m in length, seven through truss-spans, each 55 m in length, which cross the Abukuma River, and two 18 m plate girder spans. Significant damage occurred to the portal frame piers which were being repaired at the time of the inspection (Figures 7.29 and 7.30).

**Figure 7.28** General view of the Abukuma Bridge. Note the trace of pier cracking on the pier in the foreground and scaffolding at and surface preparation of the pier in the background.

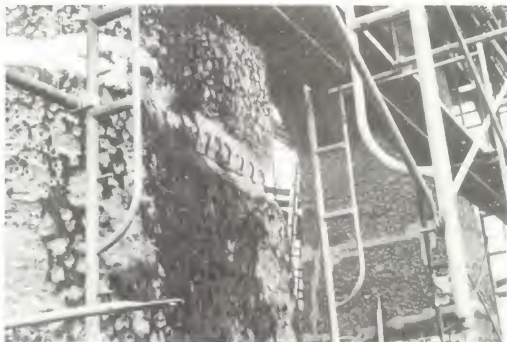
Figure 7.29 Abukuma Bridge. Outward buckling of vertical rebar at one of the damaged piers.

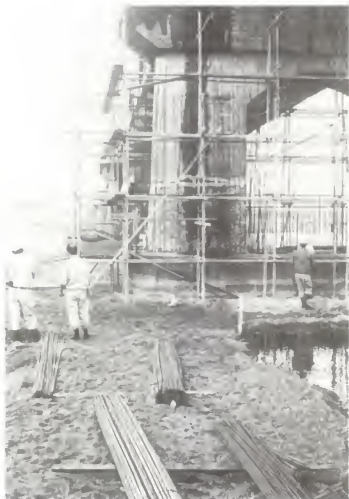
Figure 7.30 Abukuma Bridge. Typical repair of a damaged pier includes epoxy injection of cracks, epoxy covering of buckled rebar, preparation of existing concrete surface to accept fresh concrete, emplacement of vertical rebar into the footing and horizontal rebar into the pier, and an increase of the gross cross sectional area of the pier with new concrete. The technique is similar to that used on the Yuriage and Sendai Ohashi Bridges.

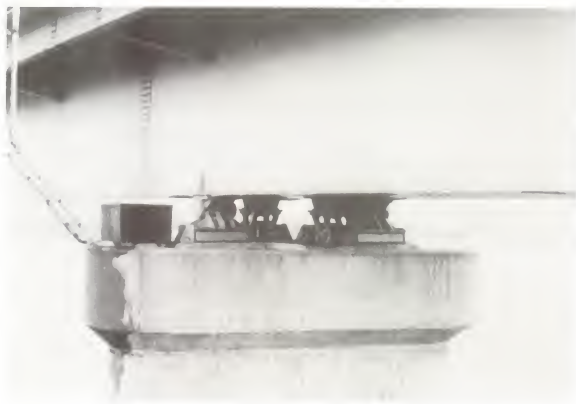
Figure 7.32 Kaihoku Bridge. Pier 2 showing the SMAC-B2 instrument (which recorded a peak acceleration greater than 500 gal. in the longitudinal direction) and the fixed bearing and hydraulic damper system.

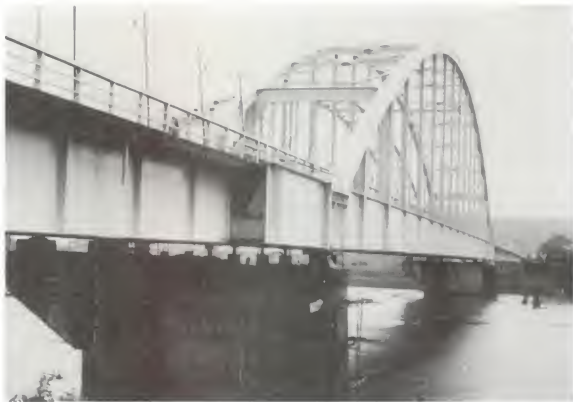
Figure 7.33 The main tied arch span of the Tenno Bridge with the cracked wall pier in the foreground. Note the smaller, pedestrian bridge in the background.

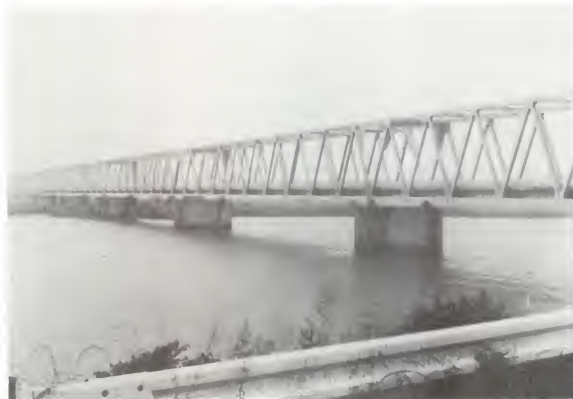
The Tenno Bridge, Figure 7.33, located approximately 50 km northeast of Sendai on National Route 45, is comprised of several steel plate girder approach spans with a tied arch main span. The total bridge length is 367 meters. The only damage occurred at the southwest wall pier where a 45° crack extended from the pier cap to a point one-third the way down the pier. Traffic was limited to one lane at the damaged pier.

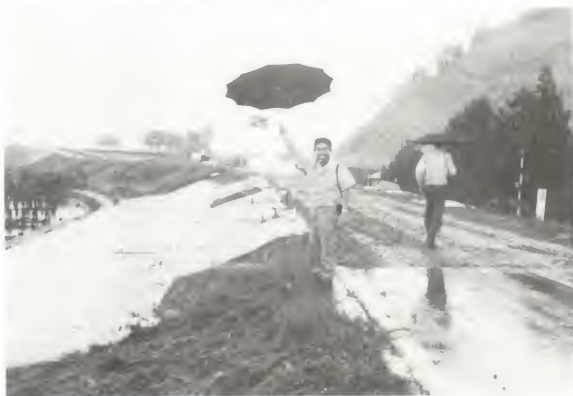
Figure 7.36 Road damage and temporary stabilization of the Kitakami Dike near the bridge site.

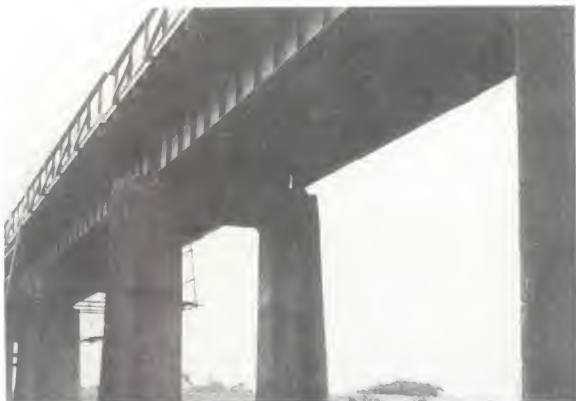
Figure 7.37 Spalled concrete at bent cap of Kimazuka Bridge.

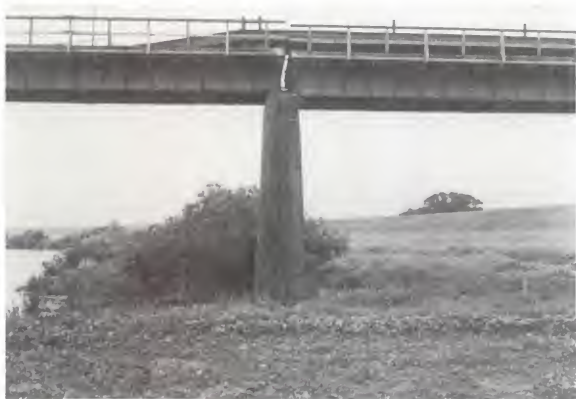
The Kimazuka Bridge, constructed in 1931, is located on Principal Route 32, approximately 35 km northeast of Sendai (Figure 7.37). It is a 19-span, simple supported, steel plate girder structure 236 m in length. Damage occurred to the top of the piers where bearing shoes pulled out of the top of the portal frame (Figures 7.38, 7.39). Longitudinal movement of the girders almost exceeded the bearing area of the bent cap. Sand boils and ground cracking were noted at the bridge site.

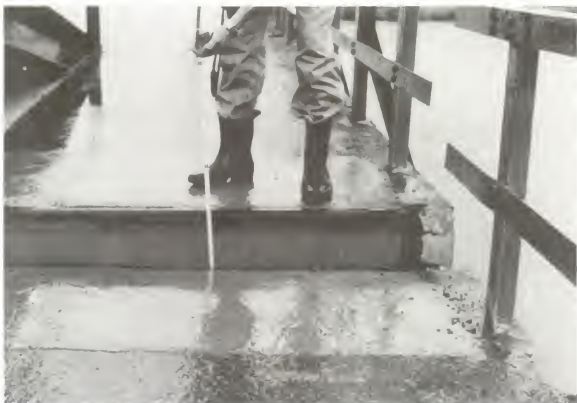
Figure 7.38 Longitudinal displacement of superstructure. Note the temporary structure which spans the dislodged main span.

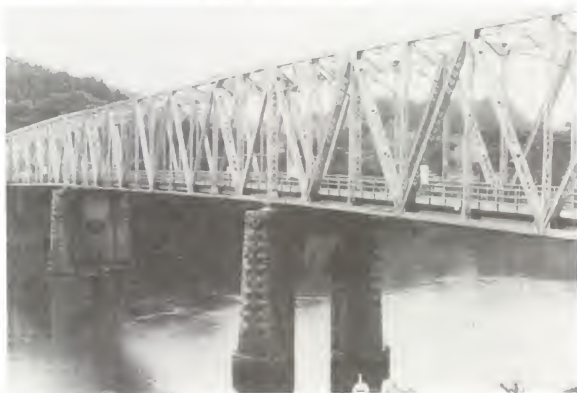
Figure 7.39 Vertical displacement of dislodged span.

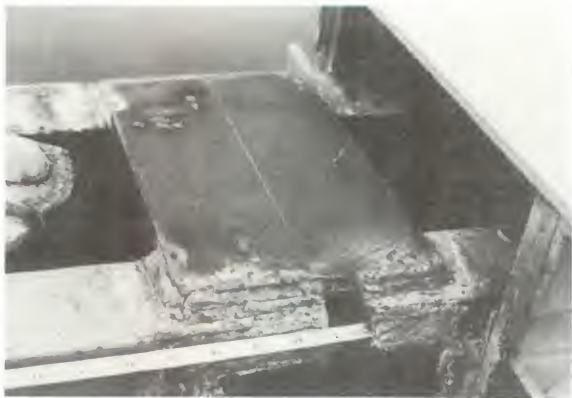
Figure 7.41 Maiya Ohashi Bridge. Steel plates welded to the top chord channel members. Note the clean fracture at a line passing through the centerline of the rivet holes of the lattice bracing and the permanent 2.5 cm separation.

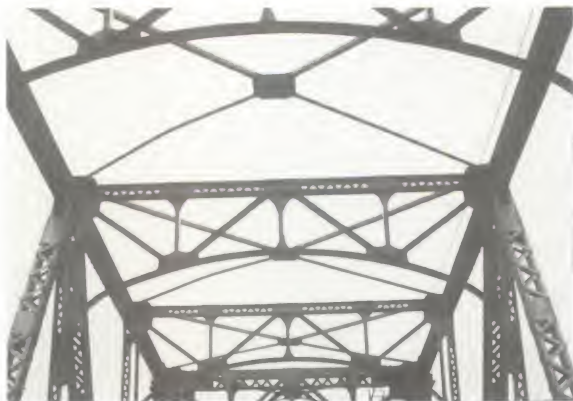
The Maiya Ohashi Bridge, Figure 7.40, is a three-span Gerber-truss bridge located on National Highway Route 342 approximately 62 km northeast of Sendai. The 181 meter long truss bridge, constructed in 1928, was closed to traffic because of a brittle fracture through the rivet holes of the top chord channel members at the first pier, Figure 7.41. Four steel plates had been welded around the top chord members. Some of the small steel angle top lateral bracing members were buckled in the vicinity of the pier, Figure 7.42. No damage was reported to either of the piers or abutments. The Maiya Bridge is scheduled to be replaced.

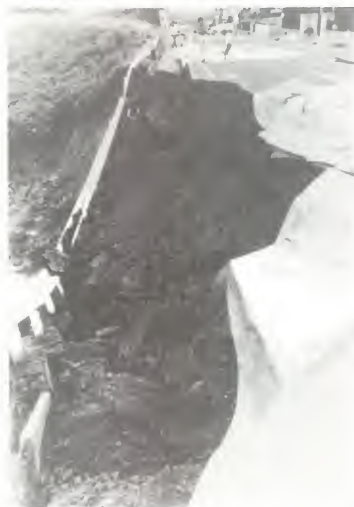
Widespread highway damage (e.g., Figure 7.44) occurred in the region north and east of Sendai. Typical damage included settlement of bridge approaches, cracking of pavements, failure of roadway embankments, and blockage of roads from rockslides. This type of damage has been documented in reports on previous large earthquakes in Alaska, Japan, California, and Guatemala and is virtually impossible to design against.

Figure 7.44 Typical Road Fill Failure.

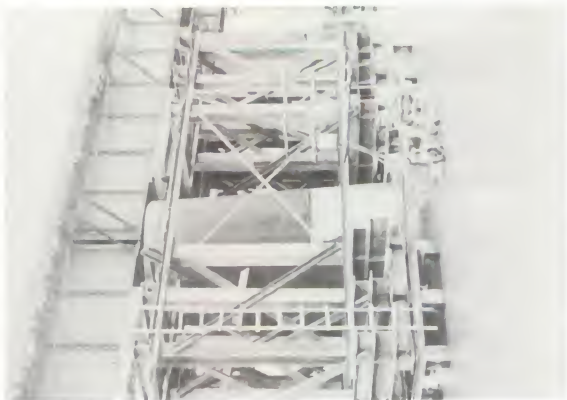
The Eai River Bridge (Figure 7.48), owned by the Japanese National Railways (JNR), is a dual eight-span steel plate girder structure 160 m in length, which is located 40 km northeast of Sendai. The superstructure is supported by massive unreinforced concrete gravity piers on caisson foundations. Ground acceleration in the area was estimated by the Ministry of Construction to be 200-250 gal. Two piers were severely damaged when large wedged shaped sections of concrete dropped out below a construction joint.

Figure 7.48 Eal River Bridge. Damaged pier of Eal River Rail Bridge. Temporary pier supports were constructed following the earthquake. Full train service was established approximately 10 days after the earthquake.

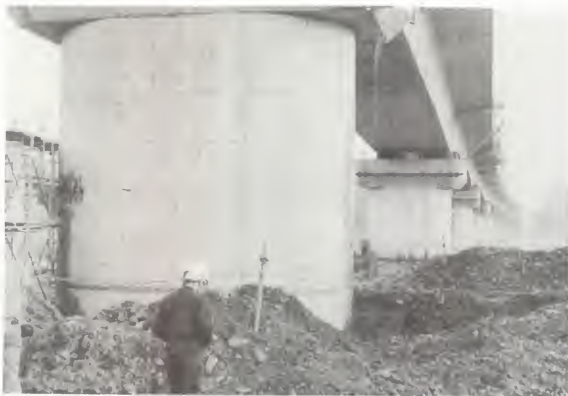
**Figure 7.49** The Natori River Bridge is a three-span continuous single cell reinforced cast-in-place concrete box girder structure on 3 m x 6 m piers approximately 8 meters above grade. Typical damage included cracking in the central part of the pier where the gross cross-sectional area of vertical steel was reduced.

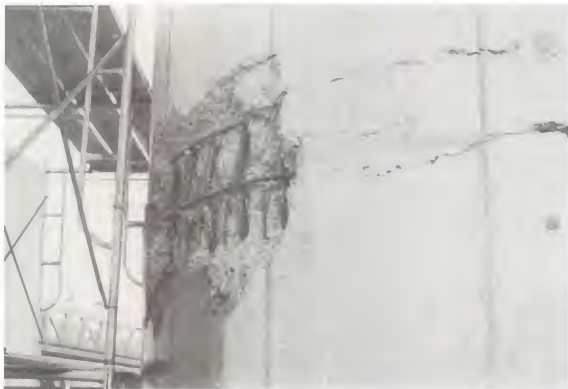
**Figure 7.50** Natori River Bridge. Detail of spalled concrete at the Natori River Bridge site showing the buckled vertical rebar.

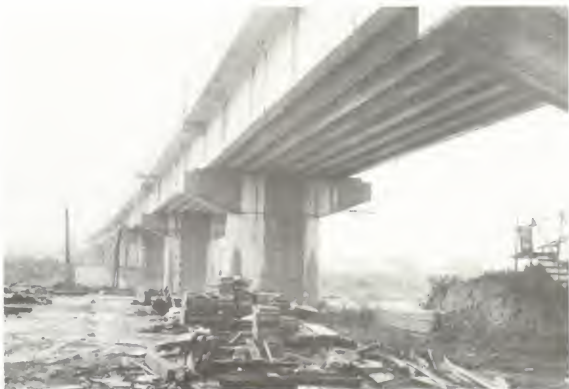
Figure 7.51 Typical structures which experienced pier cracking near the Rifu Construction Office of the Sendai Shinkansen Construction Bureau, JNR.

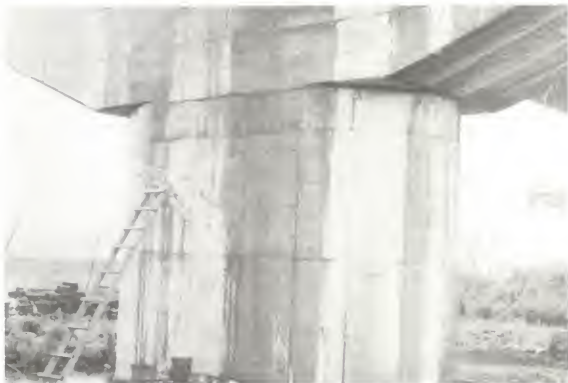
Figure 7.52 Shear cracking in the relatively lightly reinforced upper portion of the pier.

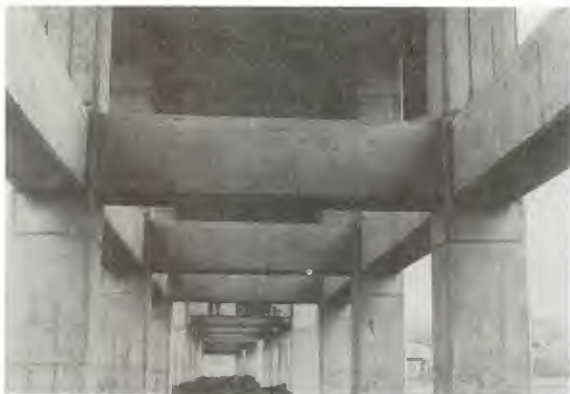
Figure 7.53 Tensile cracking of space frame tie beams near the Rifu Construction Office.

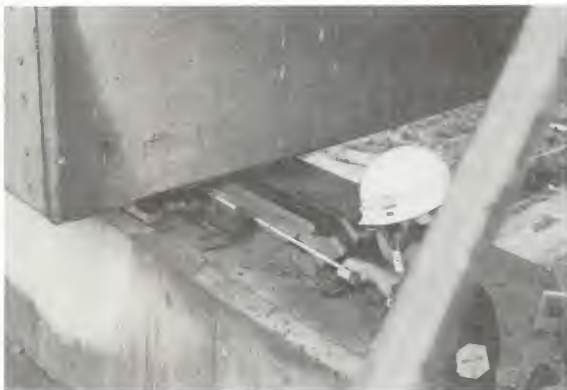
Figure 7.54 Failure of a bearing plate supporting a single cell box girder near the Higashi Sendai Construction Office. Girder displaced laterally 50 cm.

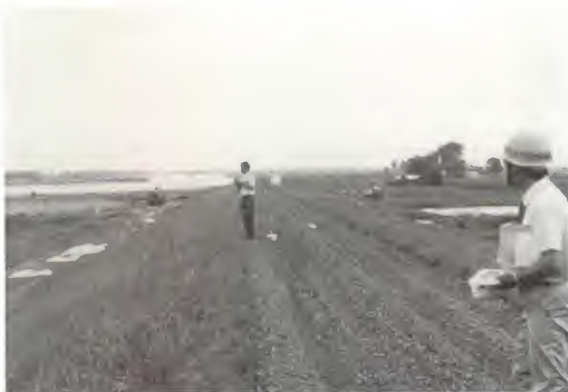
**Figure 8.2** Site 1, Natori River, view downstream (southeast) along repaired portion of dike. Dike is made of compacted sand. It rises 2 m above the high water level of the river and has side slopes of 2H:1V. Natori River in center-left background.
